ANNALES  
UNIVERSITATIS MARIAE CURIE-SKŁODOWSKA  
LUBLIN–POLONIA

Maria Curie-Skłodowska University in Lublin, Faculty of Earth Sciences and Spatial Management  
Department of Geoecology and Paleogeography

MARTA KUSZNERCZUK

Contemporary hazards of the Bug lateral erosion  
in the Polish-Belarus border area

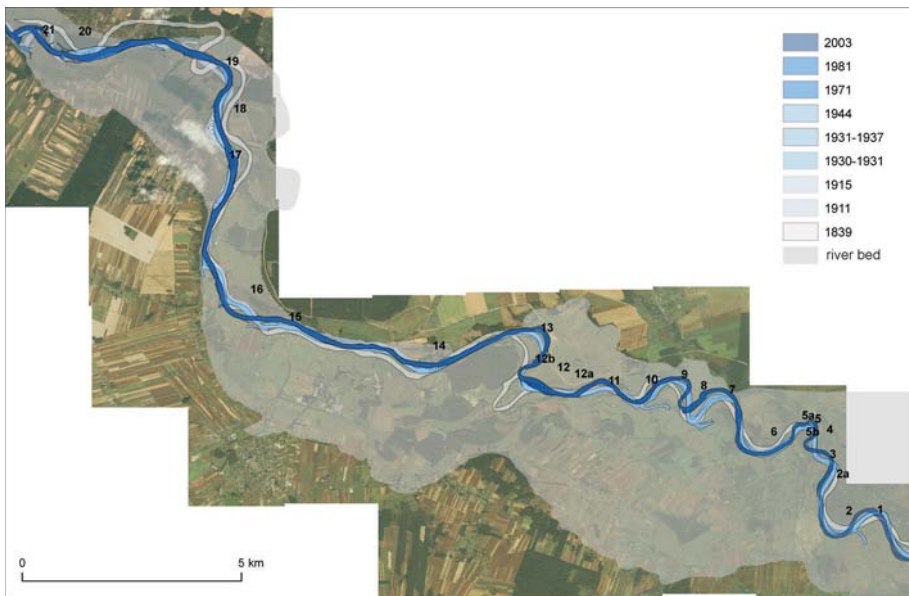
Fig. 2. The changes of Bug River channel position in the period 1839–2003

Taking into consideration the asymmetry index of bends, the odd numbers of bends (right bends) relative to the axis of symmetry are moving to the right. In the case of even numbers of bends (left bends), they are moving to the left. Using this index, the synchronous rotation of bends in the clockwise direction was observed (Fig. 2). These bends are generally sliding down with the course of the river. The Bug River in the section between Zaczopki and Gnojno has changed its position significantly since 1839. Near Wygoda and Bubel Stary two bends were cut in this period.

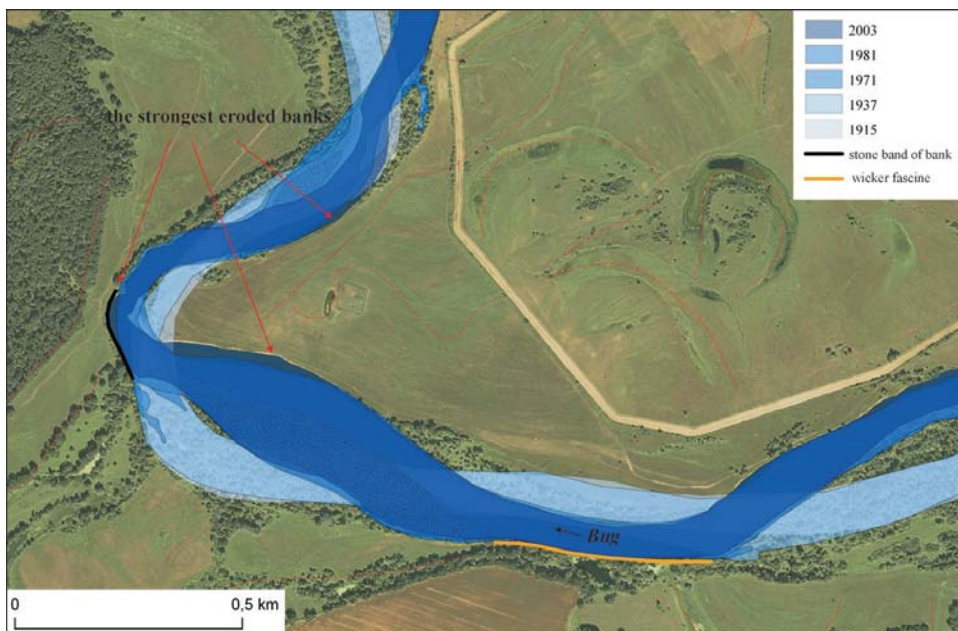
Fig. 4. The stages of bend no. 12 development

The river bend no. 12 has changed significantly. Channel position was moved over 250 m after 1944. The right bank of the Bug River is eroded there. This is strictly connected with a big (700 m in length) consolidated island. This island is separated from the left river bank by narrow, about 20 m-long arm of the channel. Certainly this island was developed as a result of fierce moving of the channel next to the right bank in the period 1944–1971. Then some part of the right bank was cut, probably it was made from more resistant deposits. This was confirmed by hand-made sound which was done within the island. The sand deposits lies on a thick series of silts under the surface (above 1.5 m). This layer of silty deposits could indicate the roof of paleochannels. The right bank is strongly eroded as a result of changes in the main river current. Since the 70's of the 20<sup>th</sup> century this right bank moved back (upwards) locally about 50 m. The narrow left arm of the channel with a small discharge is silted now. The arm which disappeared is rejuvenated only during the spring melt, when huge amount of water is pouring there. Then some parts of deposits are removed, which contributed to the deepening of this arm. This is confirmed by lithology (granulation analysis) of a small island situated in the inlet of the arm. Alternate layers of the medium-grained sands deposited by saltation during the high water level were recognized there as well as the fine-grained sands and silts deposited by suspension during the low water level in the Bug River. It is worth mentioning that this left channel arm was active for a short time. It was developed by cutting of the bend in the neck after 1839 (see Fig. 2). Because of strong erosion of the right river bank (mentioned before) after 1944, two subsequent bends were developed – 12a and 12b. In the case of the bend no. 12a the changes of its shape and its position were connected with the strengthening of this bank by 120 m in length wicker fascine in the 60's of the 20<sup>th</sup> century. In the case of the bend no. 12b, its curvature radius has a decreasing tendency. The hazardous lateral erosion was reported on the left river side since 1971. In the late 90's the stone band of the bank was used there due to prevention of the Polish territory. As a result, the lateral erosion was limited, but the deep erosion increased. The deepest channel with the strongest whirlpool in the whole research section of the Bug River valley is located there. The main lateral erosion moved just after the prevention of erosion band. This can be observed recently (since about 2004). Wide niche is developing 40 m along the river bank. The situation is presented in Figure 4.

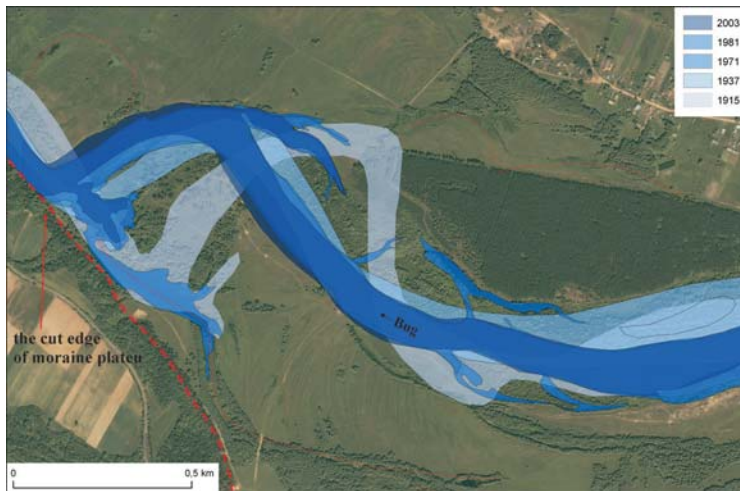
Fig. 5. The fast sliding bend no. 21 along to the cutting edge

The river bend no. 21 is the fastest downward the moving bend. Since 1911 it has changed its position by about 350 m. The more accurate measurements based on aerial photography and orthophotomaps show that in the period 1971–2003 the channel was moved downward 40 m. The changes of position of this bend are in accordance with the model of the river sliding along the cutting edge of the valley side (Davis 1954). The cutting edge is moraine plateau situated more than 30 m above the bottom of the Bug River valley. The graphic presentation of the course of event is presented below (Fig. 5).

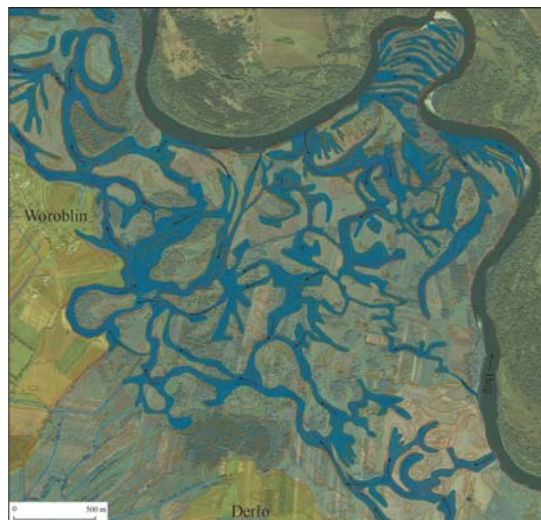
Fig. 6. The two-year floods in the left-bank Bug River valley, wide section of valley near Derło and Woroblin (based on *Plan operacyjny ochrony przed powodzią...*, 2003 and author's observation). Arrows mark the direction of flooding water in topographic depressions

There is river metamorphosis in the two sections of the investigated valley. In the wide section of the valley, between Zaczopki and Wygoda, during the high level of water the floodplain is partly flooded (total flooding occurs only during one hundred-year flood). In practice every year, during the spring thaw (normally appearing there) the land depression located closest to the river is flooded. In the two- or tree-year cycle the flooding water also fills the topographic low area located further from this river. Only some of the highest fragments of floodplain are above the surface of water. Then the Bug River has many features of anastomosis river (Fig. 6). Anastomosed rivers consist of two or more interconnected, co-existing channels with the interceptor (transport) or distributed character (Teisseyre 1991). The flooding water usually flows into paleochannels/oxbows, confirmed by fillers of mineral deposits. This flooding water flows also in overflow channels which connect the paleochannels. The erosion of floodplain occurs during that reorganization of channel.

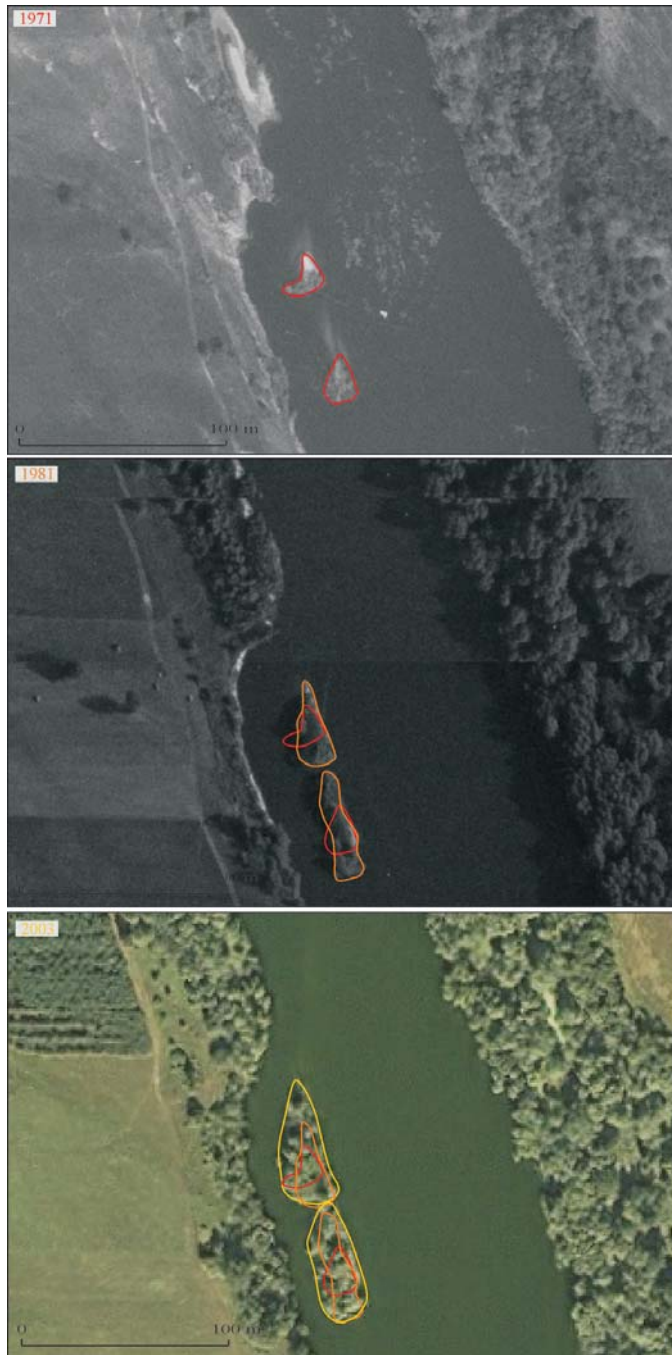
Fig. 7. The islands development near Bubel-Lukowiska in the following years: 1971, 1981, 2003

significantly higher. The river evolves to braiding in this narrow section of the valley. Islands (bars) are recently developing within the channel (Fig. 7). They are the first, slightly visible, but certain evidence for evolution of the Bug River to braiding. According to Falkowski (1970), Babiński (1992) or Klimek (1987), human activity in the river valley and adjacency to its moraine plateau play an important role for transformation of this river to braiding. In this section of the valley the aggradation is dominating.
